TE Forensics, Inc

Job #: P23-282

In accordance with your request, I have visited the site and conducted a field investigation at the Westgate housing project in Ottumwa, Iowa. The results of our investigation are presented herein. The concern is that the building is being tuck pointed but is not being done in a workmanlike manor. The building is located at 910 W Main Street, Ottumwa, Iowa. It was originally constructed in 1965. It is an 8-story concrete framed multi-family residential building. It was built for accessibility according to the Code at the time the building was constructed.

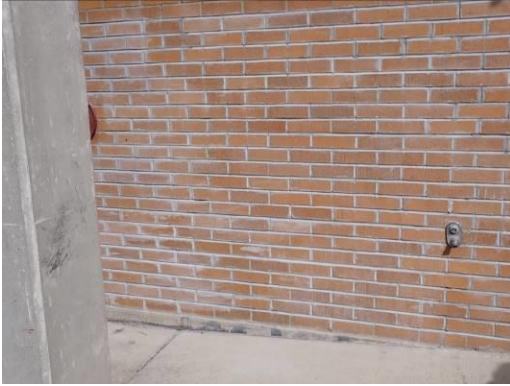
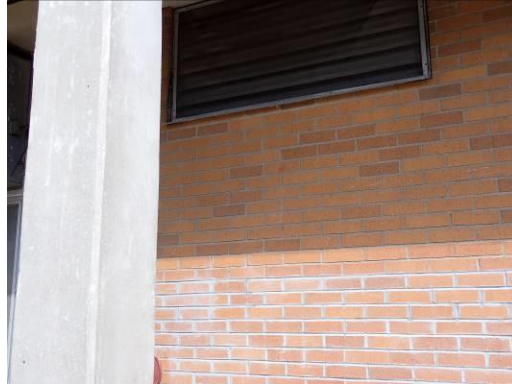
9, 10. Views of areas not cleaned

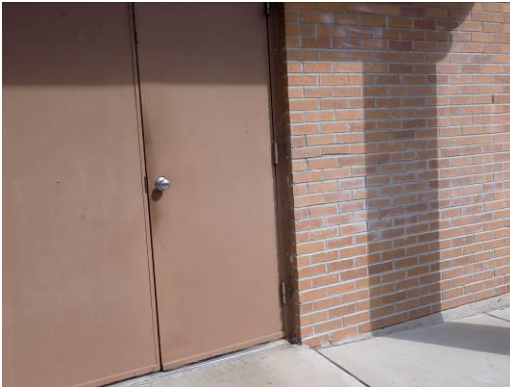
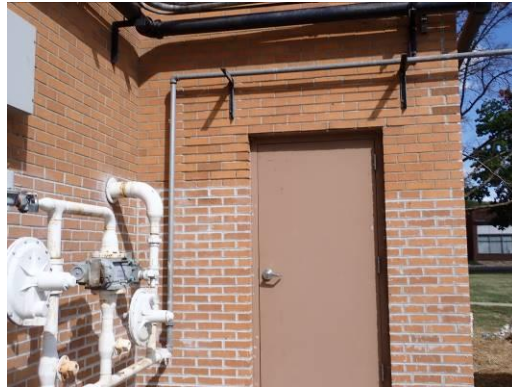
11, 12. Views of areas not cleaned

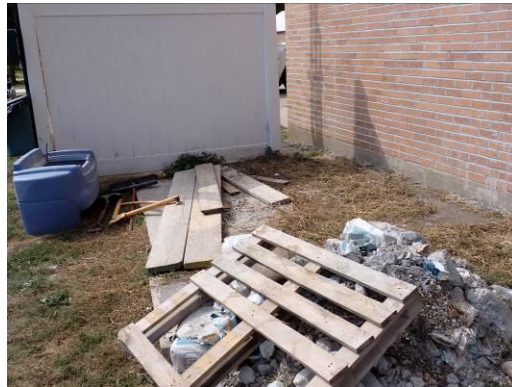
14. Debris left on site

1. The tuckpointing is not acceptable, the mortar color doesn't match.
2. The tuckpointing and cleaning is not complete.
3. It did not appear that any of the sealants were replaced.
4. The site is not cleaned up.

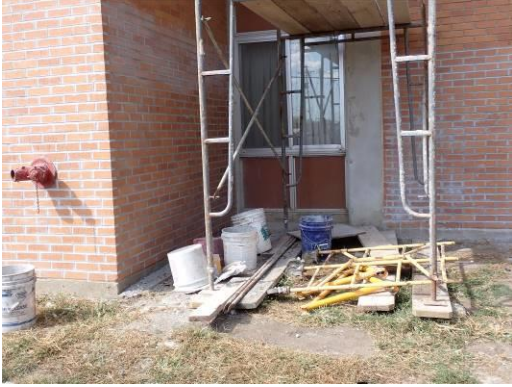
15, 16. Scaffold left on site

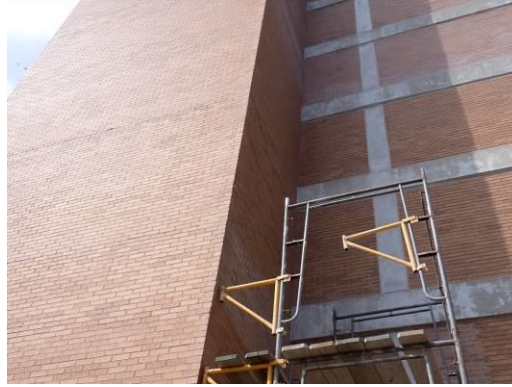
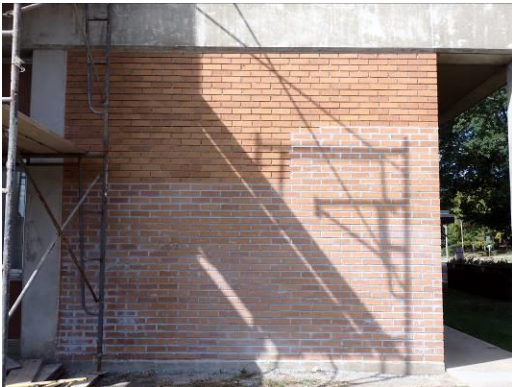
17, 18. Unfinished areas

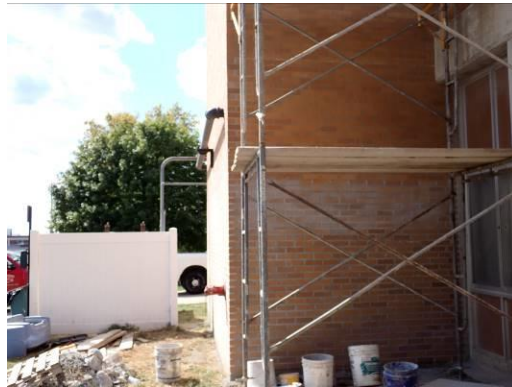
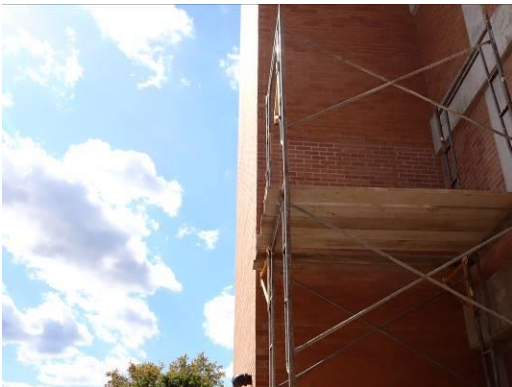
19, 20. Unfinished areas

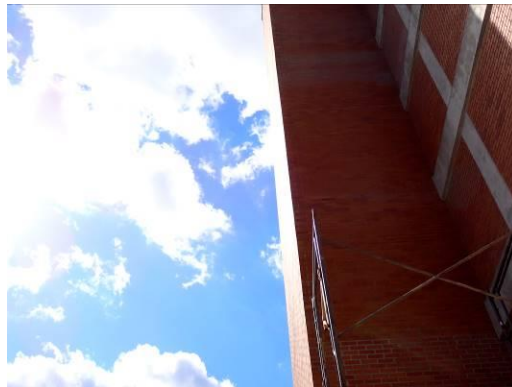
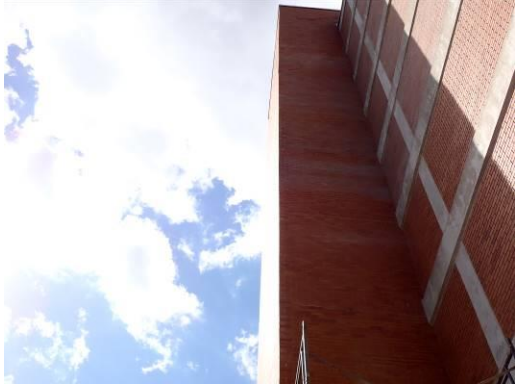
21, 22. Area not cleaned

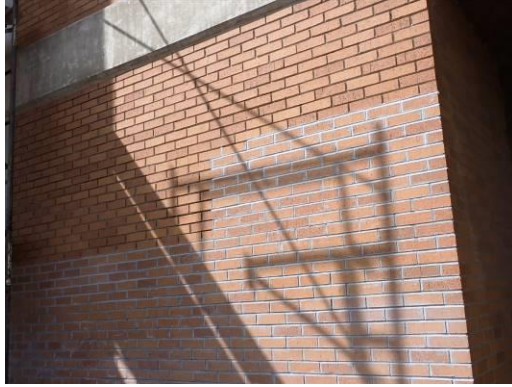
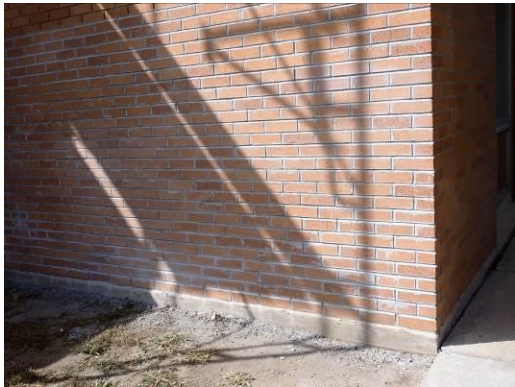
23, 24. Poor tuck pointing

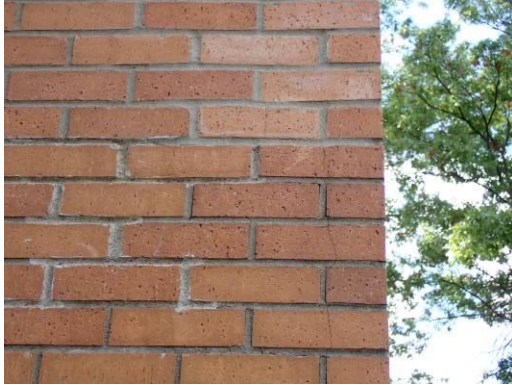
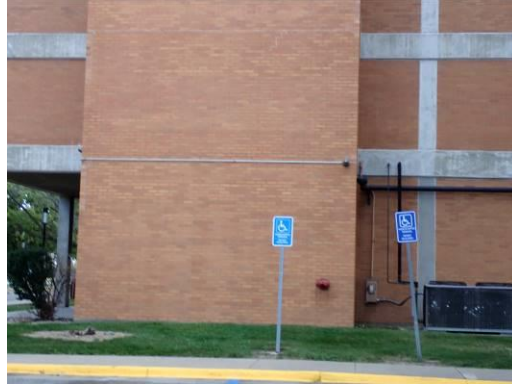
39, 40. Poor workmanship
